DNA 4377P-3

PROCEEDINGS OF THE DICE THROW SYMPOSIUM 21-23 JUNE 1977

Volume 3

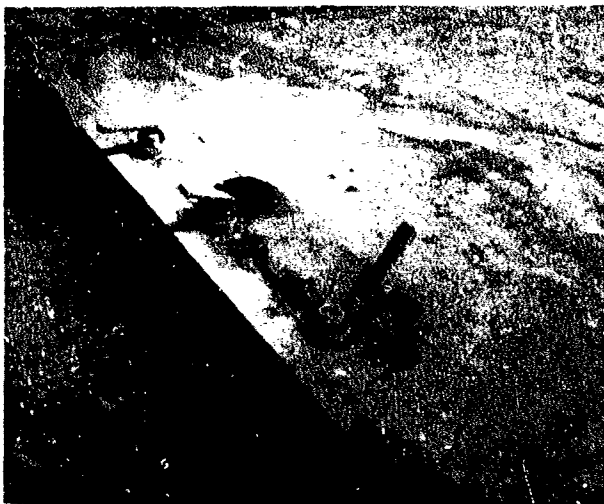
Damage to Locking Handles

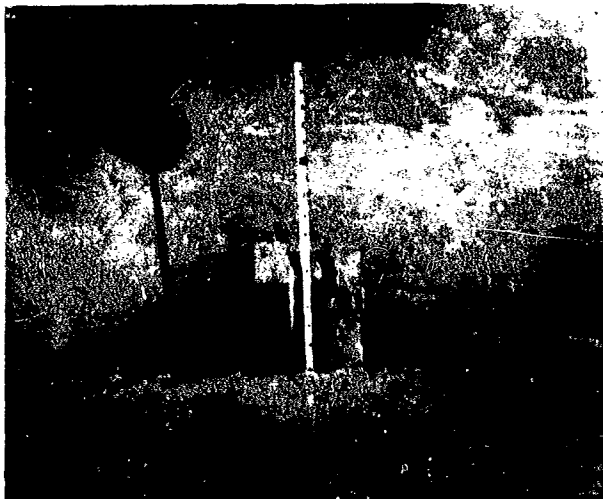
Damage to Hinge

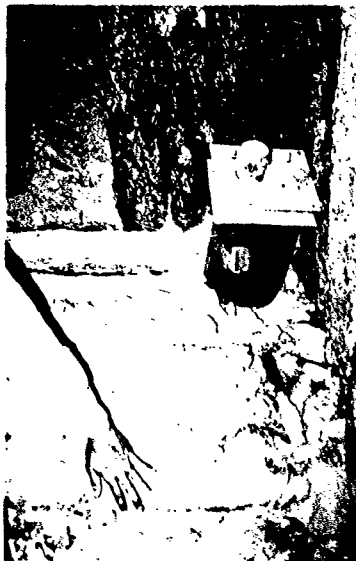
Figure 4.8 shows how the floor "puffed up" about 6 in. in the northeast corner of the shelter in the east entryway; some pressurized earth caused some earth to "flow" up into the closed room, in which the measured peak overpressure was only 1.5 psi. About 85% of the floor area was undisturbed, as was the floor in front of the man's hand resting on the cross brace. Neither the blast gauge resting on the brace pole in the corner nor the small expedient fallout meter on top of it was moved.

Fig. 4.8. "Puffed-Up" Part of the Floor of Small-Pole Shelter due to the Start of Earth Flow under Moderately Long-Duration Blast Overpressure at the 53-psf Overpressure Range.

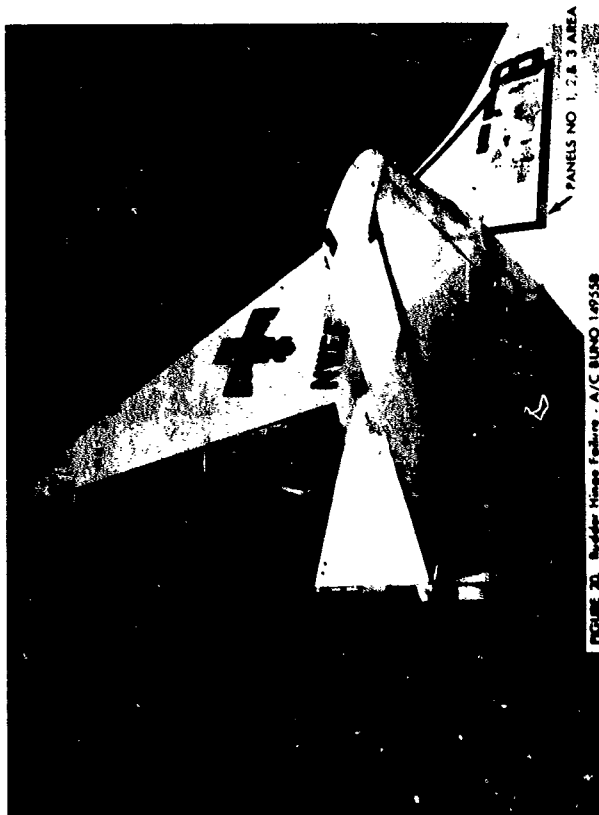
FIGURE 20. Rudder Hinge Failure - A/C BUNO 149558

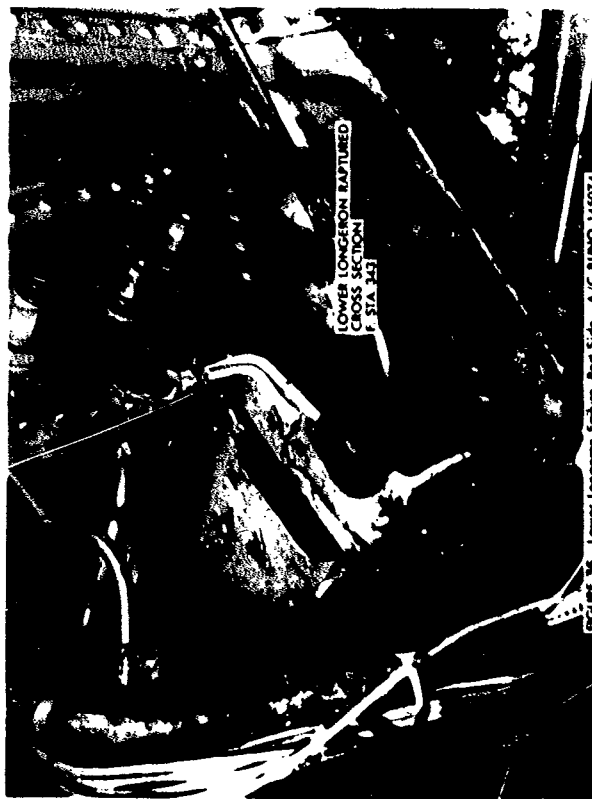
FIGURE 36 Lower Longeron Failure, Port Side - A/C BUNO 145074

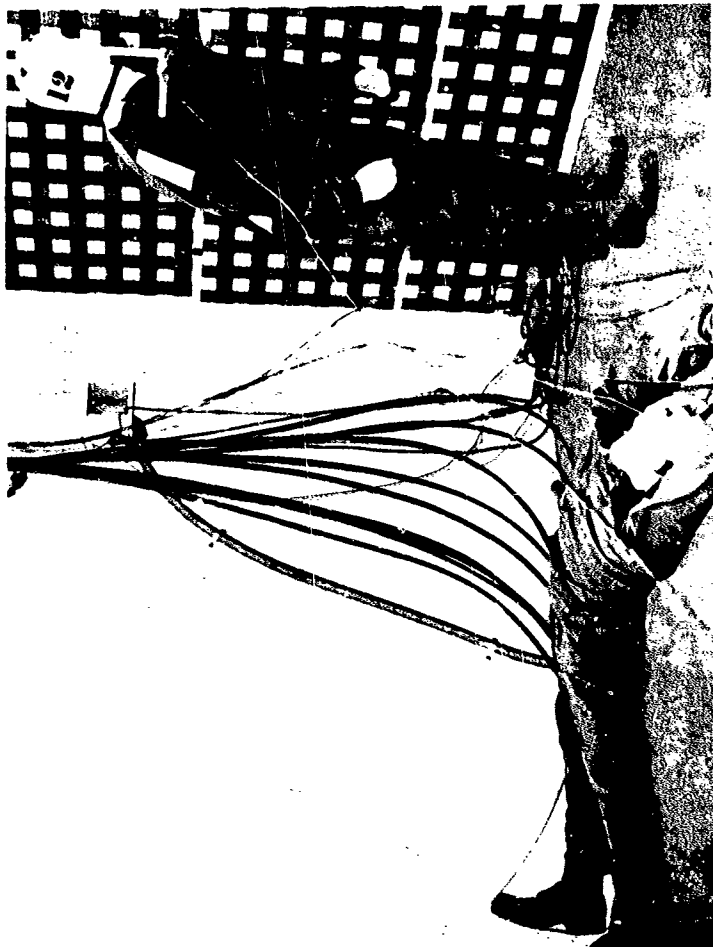
Figure 1: Postshot View of Dummies Nos. 14 (Supine) and 12 (Standing) in the Underground Personnel Shelter. Note the shoe marks on the rear wall.

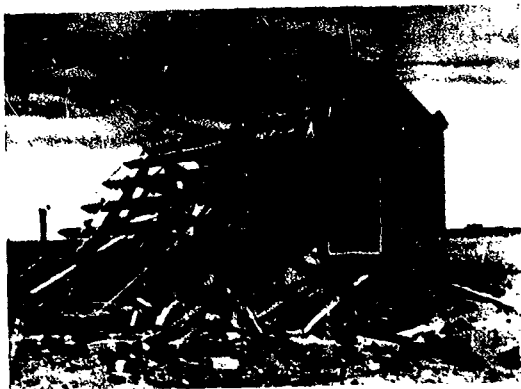
A preliminary review of the test movie for Structure No. 1 indicated that as the inward center deflection of the timber posts of the front wall became large, the mortise joints in the bottom plate fractured, except for those at the two end posts. With removal of the bottom support for the posts, the wall panels rotated inward at the bottom under the blast forces. When this occurred, the top plate of the front wall was essentially spanning the distance between the two end posts. Under the influence of the high roof dead loads, and possibly some blast forces, the top plate deflected downward at the center placing an eccentric load on the corner post between the west front and south side Fachwerk walls. The corner post fractured at the top and collapsed outward from the corner.

FIGURE 30 TWO PANELS REMAINED STANDING IN SOUTH
SIDE FACHWERK WALL STRUCTURE NO. 1

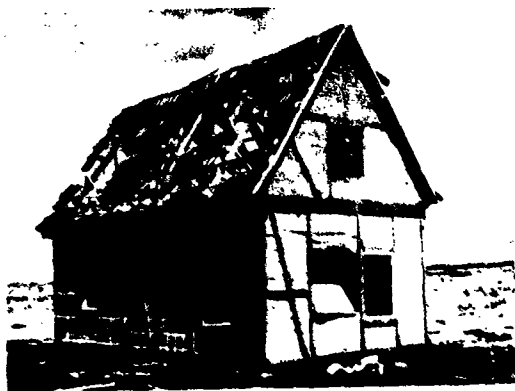
FIGURE 40 DAMAGED WEST FRONT AND SOUTH SIDE
FACHWERK WALLS STRUCTURE NO. 2

Figures 40 and 48 show the damage to the roof tile. Each half of the roof had 12 rows of 43 tiles for a total of 516 tiles. As shown in Figure 40, the front tile was damaged in all sections of the roof, but damage was

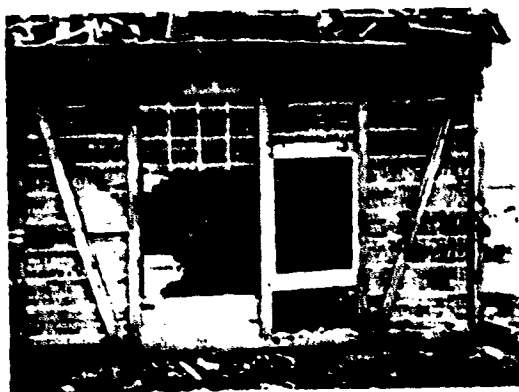
FIGURE 41 DAMAGED WEST FRONT FACHWERK WALL STRUCTURE NO. 2

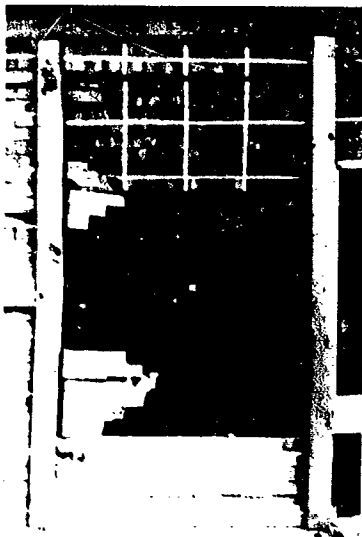
FIGURE 44 DAMAGED 48-IN. WIDE PANEL ON FRONT
FACHWERK WALL STRUCTURE NO. 2

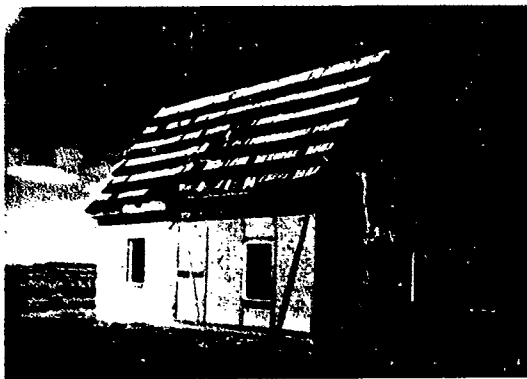
FIGURE 49 POST-SHOT VIEW OF STRUCTURE NO. 3

Figures 49 and 51 show the minor damage to the roof tile. Of the 516 tiles on the front roof surface, 20 percent were broken or missing. As noted previously for Structure No. 2, the tile damage for Structure No. 3 was also concentrated in the lower courses on the front roof and the upper courses on the rear roof.
